**Post Occupancy
Evaluation**

**- Carnegie College
Functional Performance
Review Condensed Report**

Prepared for: Andrew Chamberlain
Project Director
Scottish Funding Council

16 July 2008

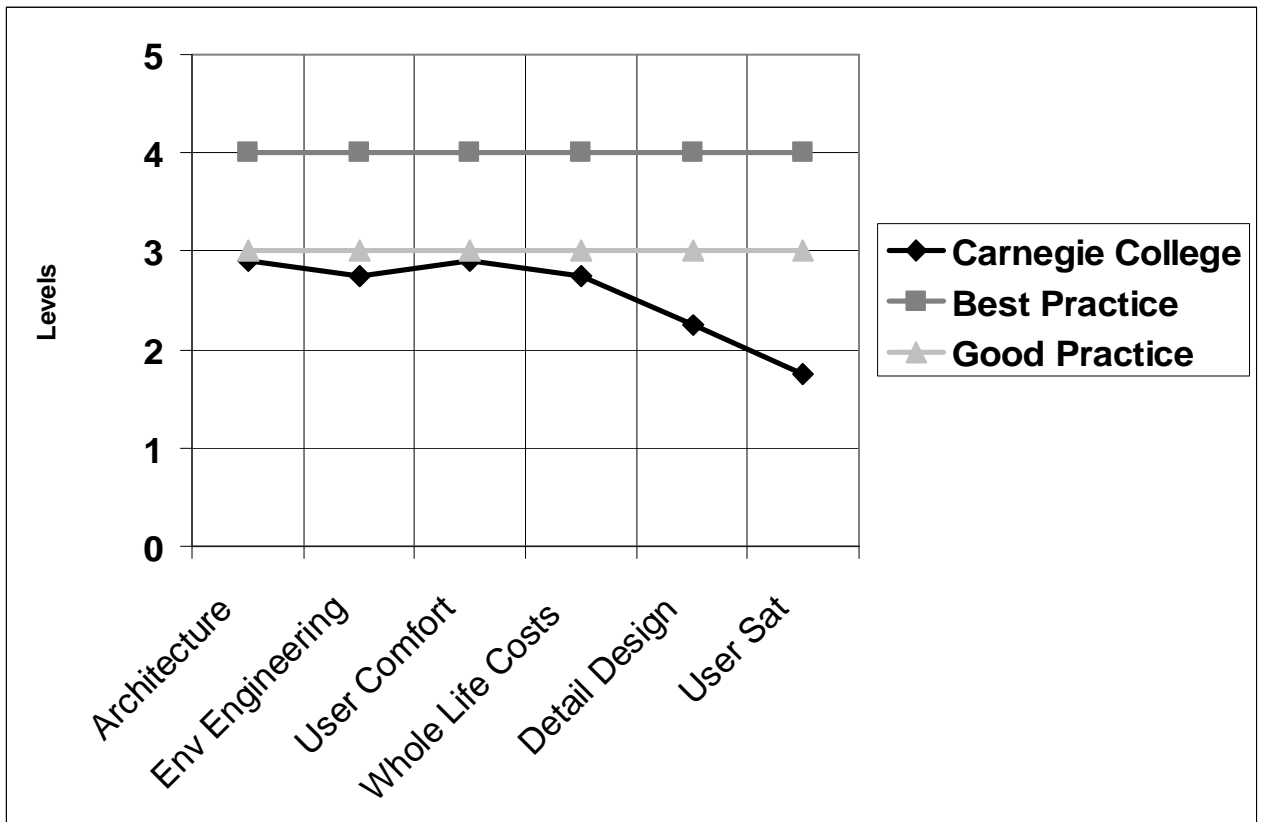
3.2.1 Matrix 0 – Summary matrix

The above matrix is the summary of the six matrices and gives an overview of the results. It shows that environmental engineering, whole life costs, detail design, and user satisfaction

are below Good Practice. User satisfaction scores are inevitably subjective and we treat these interviews as anecdotal evidence – a more widespread rating of user satisfaction has been provided through the occupant consultation. The 6 individual matrices, provided in the main report show more detail, particularly aspects of the matrices which influence the median scores in the summary matrix. It should be noted that this is an interim rating that will be reviewed in the light of further information, such as energy data and a post-construction BREEAM rating.
