A Case Study of a FE building

Merton College

This case study reviews a recently-completed FE building in Merton College, London. The aim of the study is to evaluate the building by undertaking a post-occupancy evaluation and share the evidence-based lessons within the further education sector.

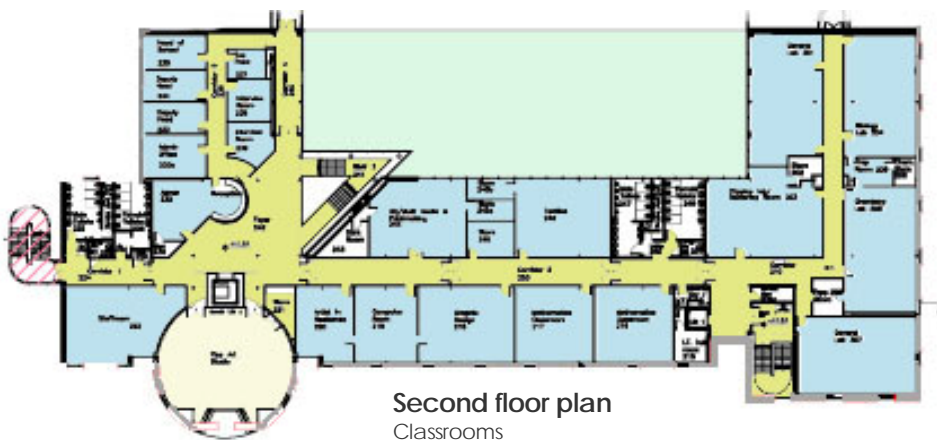
Second floor plan

Classrooms
Administrative and staff offices

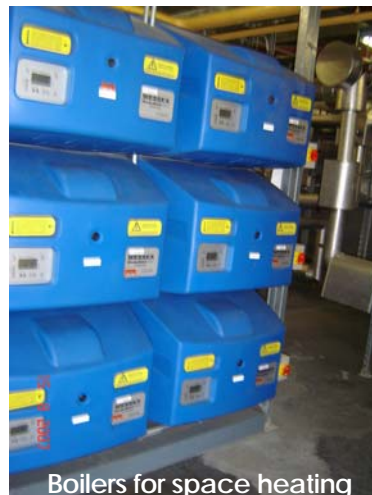
The space and hot water in the building is provided by two Wessex ModuMax 250/750c condensing gas boilers. Each boiler, has three 250 kW models stacked vertically, which makes it six units in all to serve the entire site. The boiler is floor mounted and has been sized to even include the next phases of construction and refurbishment.

Smaller units in the boiler ensure that the only the requisite number of units work to provide the required heating demand, instead of the entire boiler and hence is more efficient, especially for larger sites. The heating system is connected to a building management system (BMS) which determines the required number of boiler units to provide for the heating load. Hot water is provided through two Dorchester DR-LA range of hot water storage heaters.

Boilers for space heating

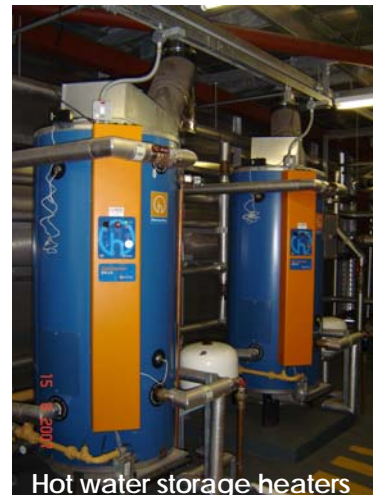
Hot water storage heaters

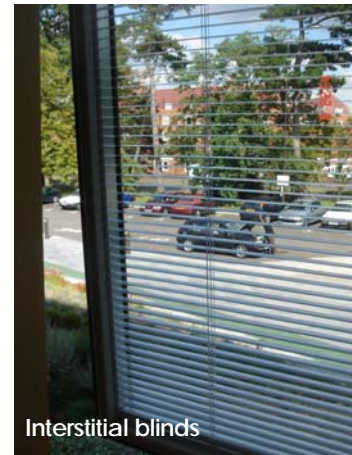
The building appears to be generally well lit with adequate amount of natural light in most spaces. The building is orientated east west with front elevation of the building facing east. All windows except on the north side of the building have interstitial blinds between the two glass panes of double glazed windows. Interstitial blinds reduce the glare and are also more effective at reducing heat gain from outside than internal blinds.

Interstitial blinds

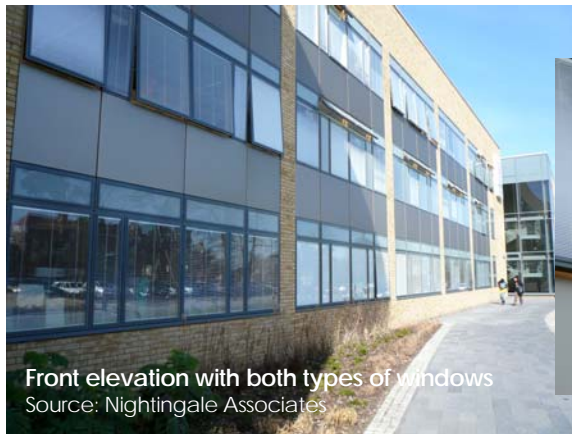
The building is naturally ventilated. There are two types of windows in spaces. The lower level large windows are manually operated by users. The windows are designed to be easily operable; however, they only open by a marginal amount. The top level smaller windows are controlled by the BMS to open or close automatically depending on the temperature inside the room. In winters, these windows are used to provide background ventilation without causing cold draughts. Every room has been given a manual override by which the users can choose to open or close the top level windows. However, these controls do not allow controlling the windows individually.

Front elevation with both types of windows
Source: Nightingale Associates

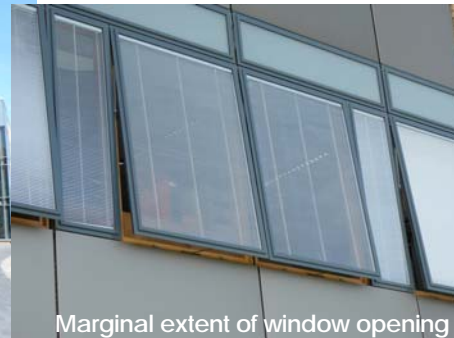
Marginal extent of window opening

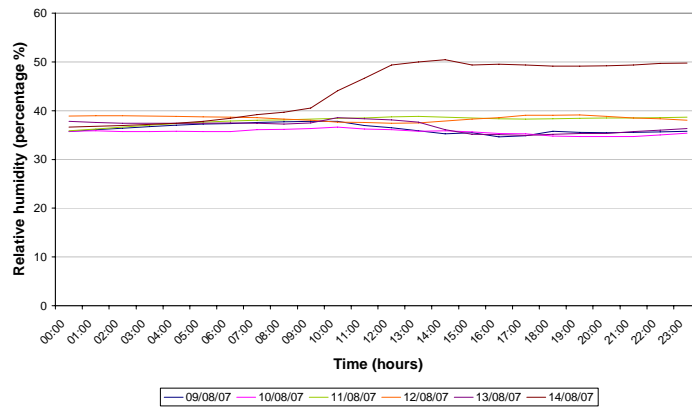
Relative humidity in library and IT over a period of one week in august

- The IT area has higher RH levels than the classroom of about 38%, but remains well within the comfortable range.

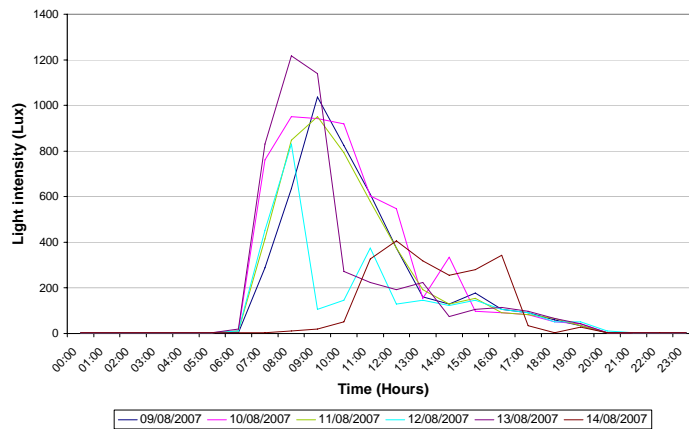
Light (Lux) levels in classroom over a week in august

- The room is east facing and therefore has very high lux levels in the morning from sunrise till 9 am when the room must be receiving direct sunlight. After noon the light levels are close to 300 lux.

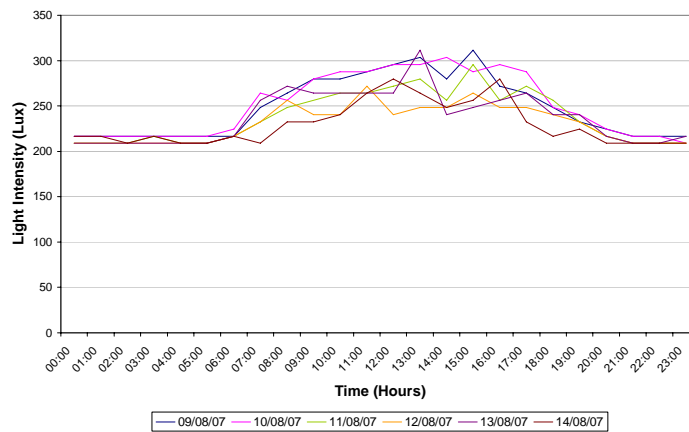
Light (Lux) levels in the library and IT over one week in august

- The light levels in the library and IT area are generally between the ranges of 250-300 lux during the day.
- The light level of about 200 lux even during the night suggests, that there are probably security lights switched on in the area.

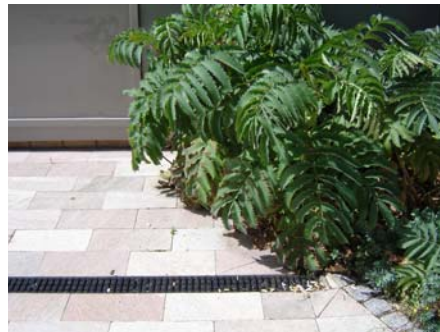
The college harvests rain water from landscaped areas on the ground floor. The water is collected in an underground tank where two levels of disinfection and treatment is carried out. It is then pumped to an overhead tank and distributed for toilet flushing and landscape irrigation.
