**Post Occupancy  
Evaluation**

**- Cumbernauld College  
Functional Performance  
Review Condensed Report**

6 June 2008

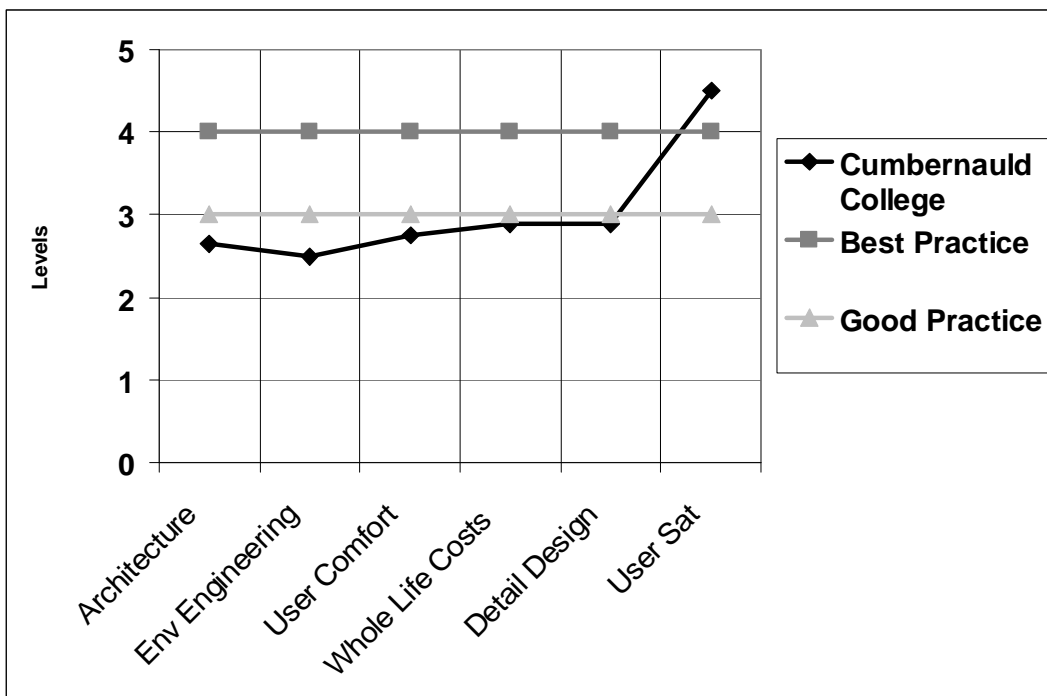
DQM Summary of results for Cumbernauld College

Initial, interim findings suggest that that user comfort, environmental engineering, and architecture are below Good Practice in certain aspects– many of which relate to management and operational issues which can be addressed in future. However, the potential lack of environmental sustainability is of some concern, but this area will have to be reviewed in the light of further information and data – and there are

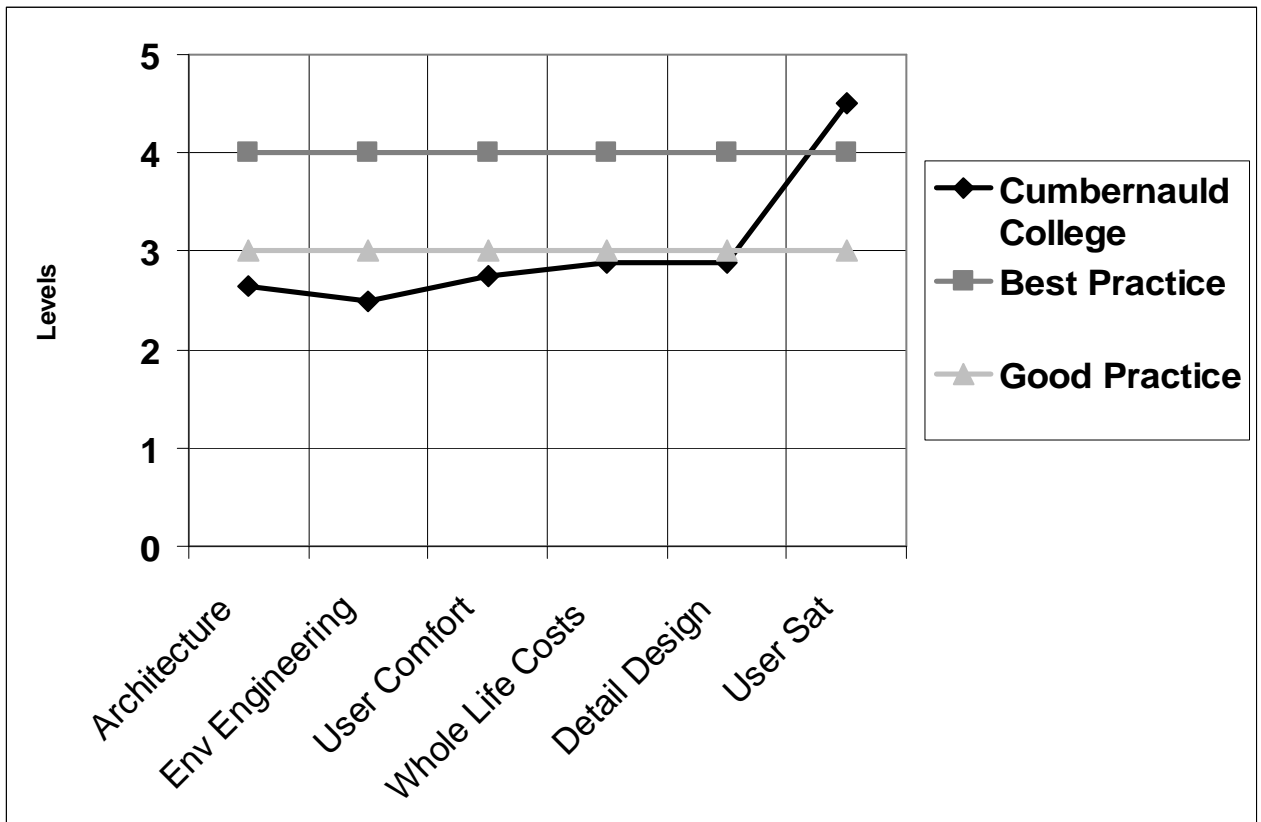
##### 3.2.1 Matrix 0 – Summary matrix

##### 3.2.2 Matrix 0 – Summary matrix commentary

This is the summary of the six matrices and gives an overview of the results. It shows that user comfort, environmental engineering, and architecture are below Good Practice. User

The matrices used in the DQM identify levels ranging from 0 to 5. Level 5 is exemplar; Level 4 is Best Practice; Level 3 is Good Practice; Level 2 is Standard; Level 1 is Poor; and Level 0 is Unacceptable.
